energy

Bulletin

ISSN 1323-8957

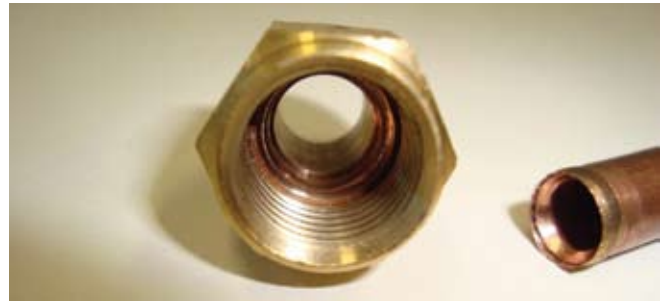
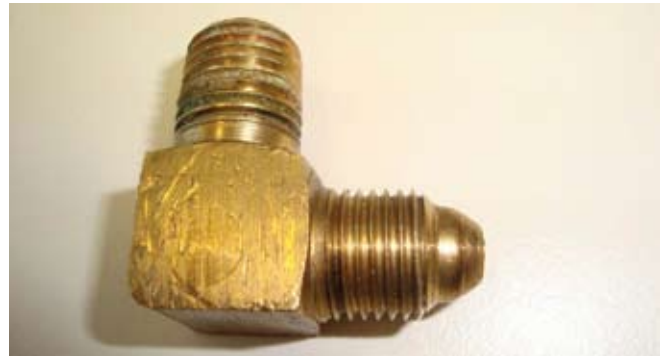
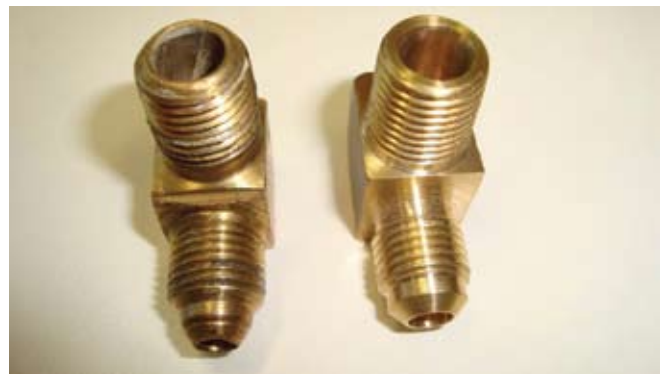
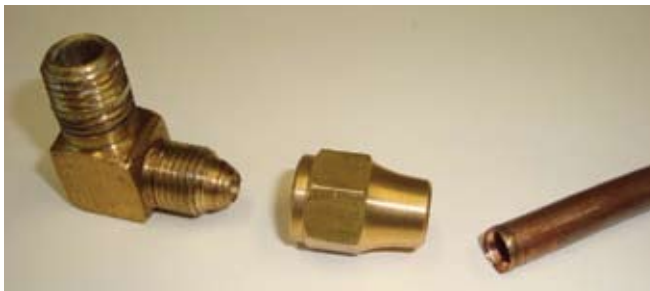
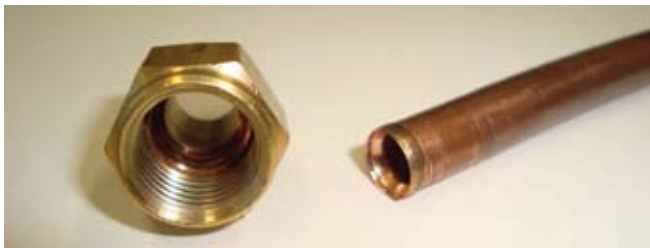
Components of flared fitting

When tightening the flare nut, it has been found that the action of rotating the nut against the copper tube that is mated against the flared surface of the brass fitting is causing the brass to distort. The brass in these fittings has been found to be soft and, as a consequence, does not form an adequate mating surface between the copper tube and the brass flare. In some instances, there has been a narrowing of the wall thickness of the copper tube at the flare, resulting in fracture of the copper.

Fracture of service lines, post installation, is considered a serious safety issue.

AS/NZS 1425 Clause 4.4 requires that fittings for copper tubing be 900 flare connections in accordance with AS D26 or SAE J533.

Gas fitters are responsible for ensuring the fittings they use on an autogas installation in a motor vehicle LP Gas conversion meet the requirements of AS/NZS 1425 and should verify this with their supplier.

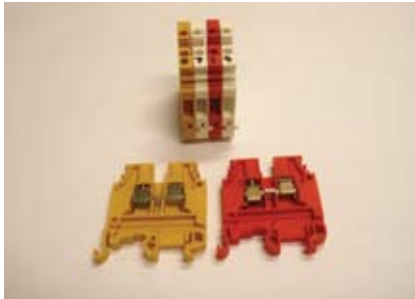
Din connectors

It was found that an electrical din connector had been installed in a reverse orientation, causing a direct short between the adjacent terminals. The din connectors used were symmetric and it was not obvious that the terminal had been installed incorrectly. This caused the main safety shut off valves to open before the pilot start up sequence.

Under normal operation, the safety shut off valves should not be opened until the burner has been successfully started. The early opening of the safety shut off valves fills the appliance with a combustible air/gas mix which is ignited during the burner start cycle.

An investigation found that a din terminal had been incorrectly installed by an unqualified employee of the burner agent while modifying the burner control system to comply with Australian requirements (installing test fire link).

Established commissioning practices would not have revealed this fault before an incident occurred. It is suggested that commissioning agents observe the gas pressure at the burner when running burner start cycles. This would indicate the early opening of the main shut off valves and action could then be taken before the incident occurred.

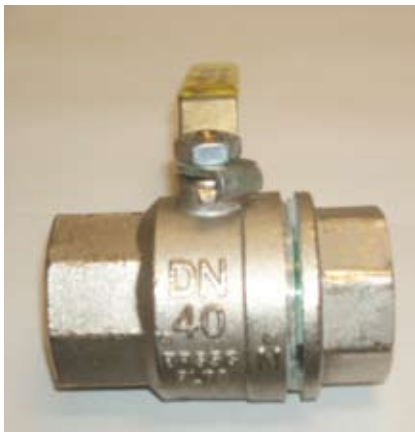
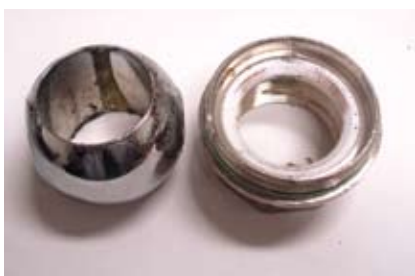
Ball valve

Recently during a pressure test, a new 40 mm ball valve was found to be leaking. Inspection of the failed valve revealed a trail of thread sealant along the lower internal surface of the valve. Following installation, and before the valve was operated, the sealant had set and on closing the valve, the sealant cut the soft seal on the ball valve causing it to leak in the closed position.

The poor work practice, resulting in an excessive amount of thread sealant accumulating in the valve, was not only expensive (replacement of the 40 mm ball valve) but could have resulted in a major incident from the leaking isolation valve on a Type B appliance.

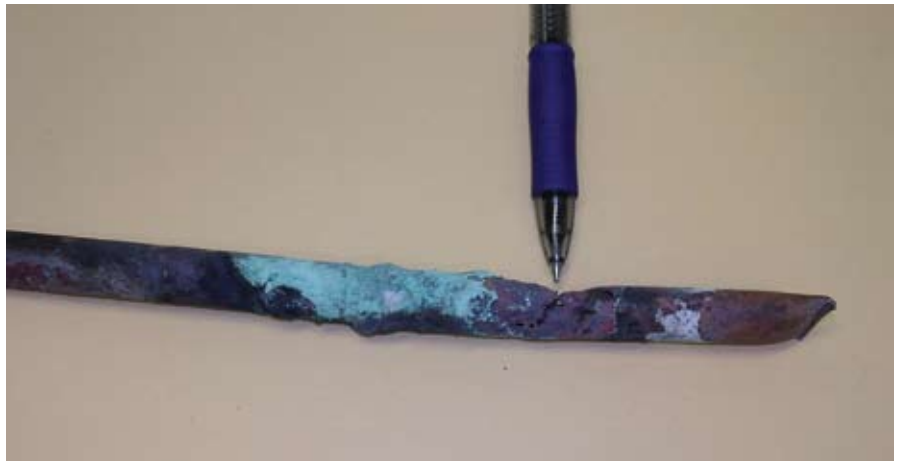
Corroded copper pipe

A pressure test was applied to the gas installation and a full drop was noted. The gas was turned back on and using an electronic leak detector, the source of the leak was found to be from within the cavity wall, where 1/2" copper tube had been inserted into the double brick wall to connect the bayonet point on the inside.

pipng in a corrosive environment" states: "Where a pipe or fitting is to be installed in a corrosive environment the pipe or fitting shall be protected".

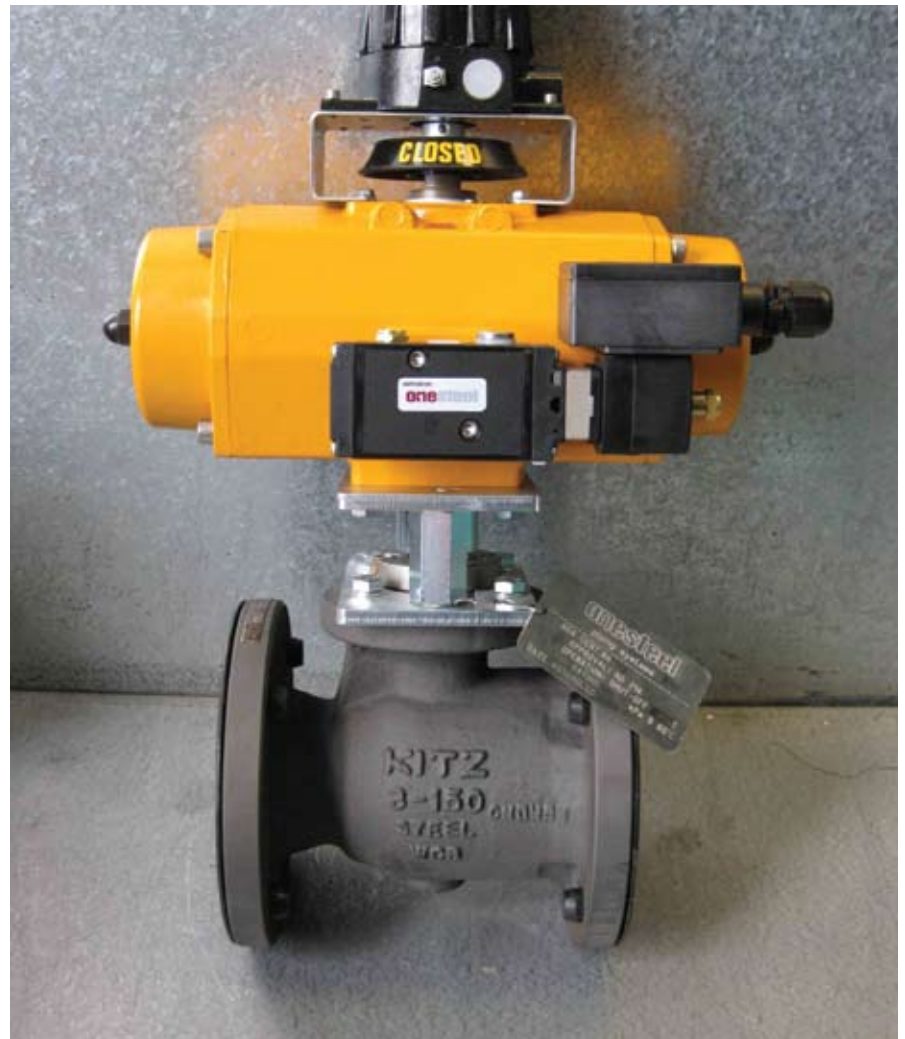
Investigations conducted by the Gas Inspection Branch uncovered 'doctored approval certificates' and unauthorised use of a copyrighted logo. All this material was passed to the Australian agent to follow up with the valve supplier should they decide to take action.

Valves such as these are readily identified by the data plate fixed to the body of the valve

issued an Inspector's Order to have the 14 valves removed and replaced before the gas installation was to be placed into service. This has now taken place.

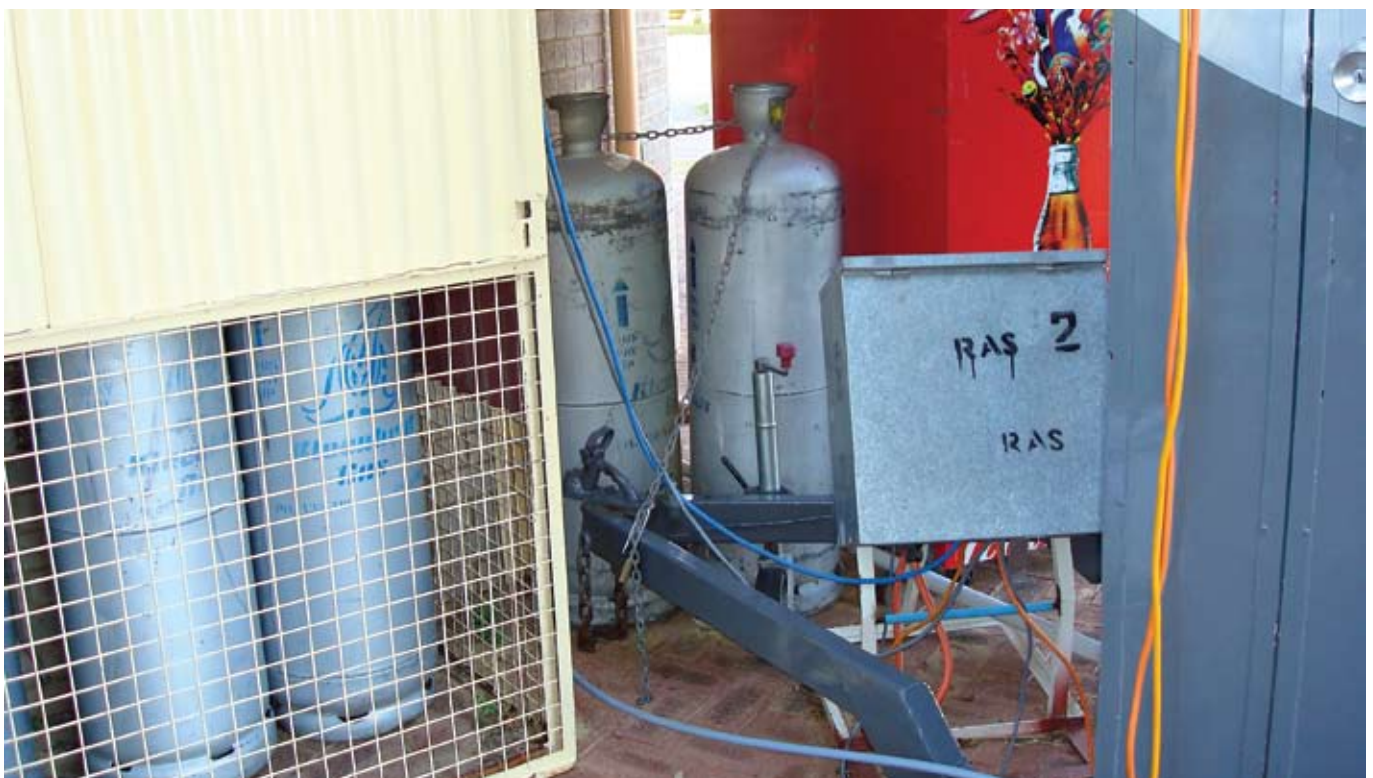
inside the hazardous zone as defined in Appendix F Hazardous Areas of AS/NZS 1596 "The Storage and Handling of LP Gas".

Although it is deemed that the gas cylinders do not present the hazard, the positioning of the switchboard and the cool drink vending machine cause the potential hazard.

The gas inspector had no option but to issue an Inspector's Order to have this potentially dangerous situation made safe. EnergySafety's gas inspectors may not be able to attend all the regional shows and events and ask the local gas fitters/plumbers to be vigilant and report any installation similar to the one in the photograph. Should this situation occur, request the organisers of the event to remove/relocate either the gas cylinders or offending electrical equipment to avoid these types of hazards.
