energy

Bulletin

New Guidelines for the Safe Management of High Voltage Electrical Installations now published

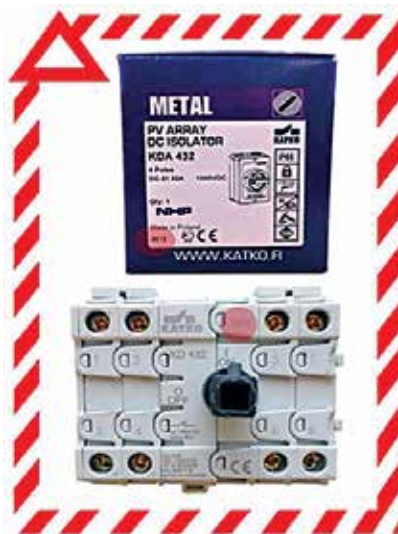
These products contain a component that has been assembled with the incorrect material, which causes the "On" switch to remain "On", even if the handle indicates that it is "Off". An electrical contractor is at risk of receiving an electric shock during maintenance and installation of these products.

EnergySafety wishes to alert electrical contractors about the recent recall of two DC solar isolator switches. Electrical contractors must cease installing the products detailed below and contact the relevant manufacturer for a replacement.

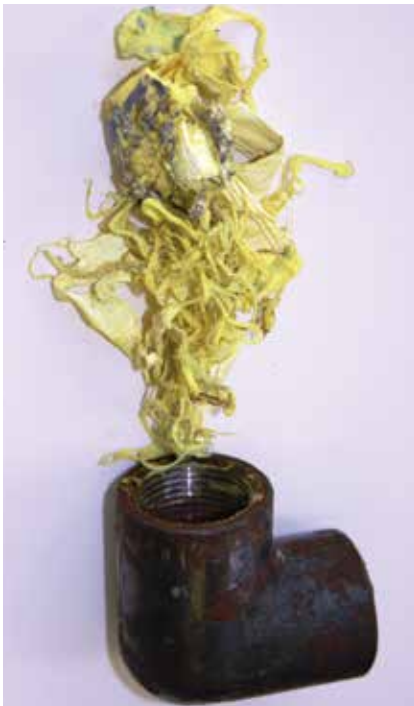
Steel elbow and threadseal tape removed from the fitting.

A steel elbow found on a commercial range had literally a swinging elbow, the amount of threadseal tape removed from this joint is also shown. In this particular case the gas fitter assembled the fittings with a copious amount of threadseal tape. A tapered thread with a tapered mating threaded fitting will “Bite” with only a small amount of threadseal tape, or a small amount of pipe jointing paste.

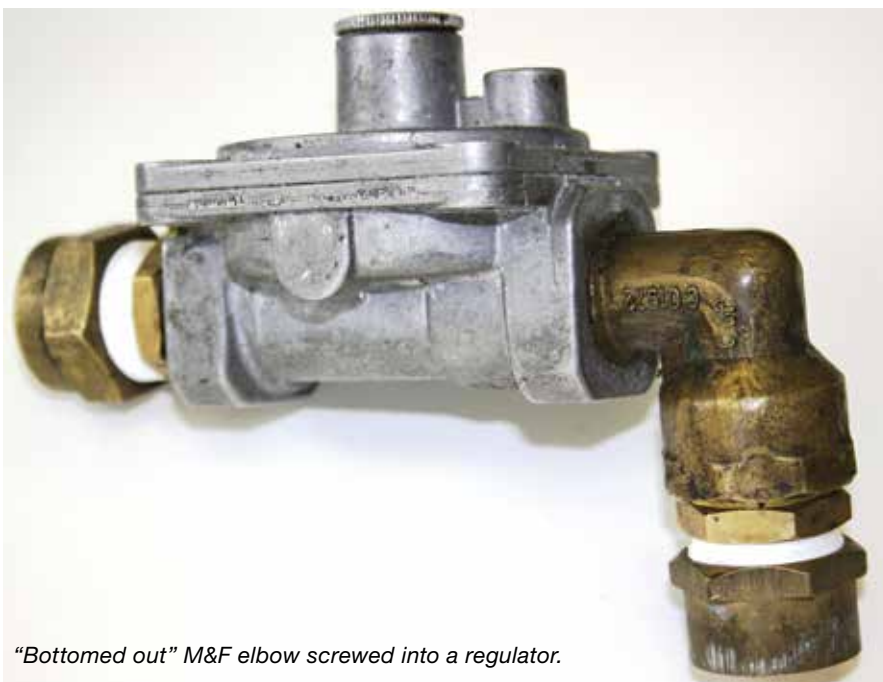
Unfortunately some have trouble recognising a parallel threaded fitting compared to one having a taper. Examples shown include a M&F elbow screwed into a regulator “bottomed out,” in this case the gas fitter attempted to seal the joint with an anaerobic thread sealant.

“Bottomed out” M&F elbow screwed into a regulator.
