## 5. Findings

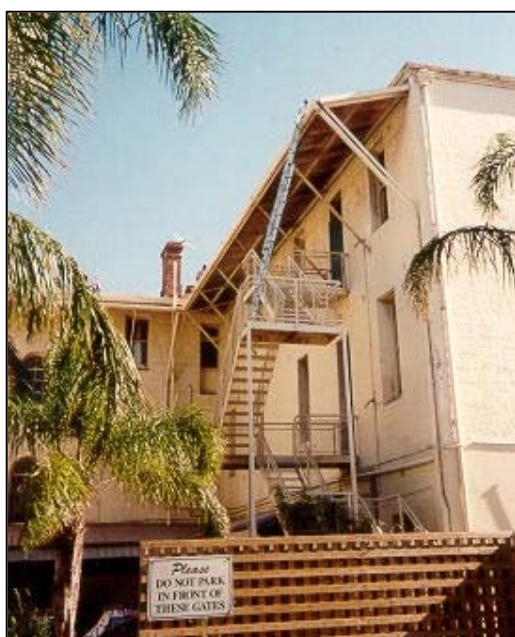
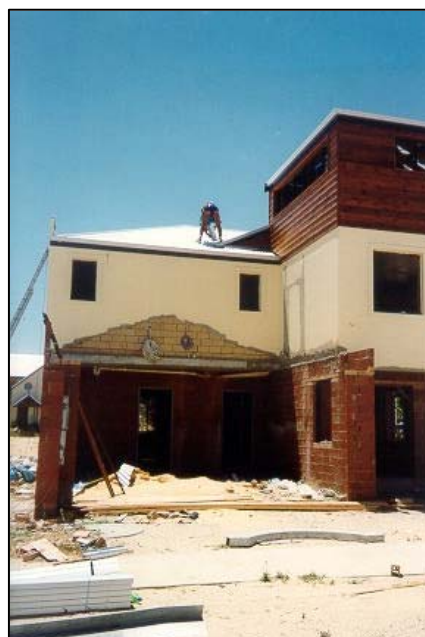
*Roof edge protection... what roof edge protection??*

*Workers in Western Australia exposed to the risk of a potentially fatal fall from a roof.*

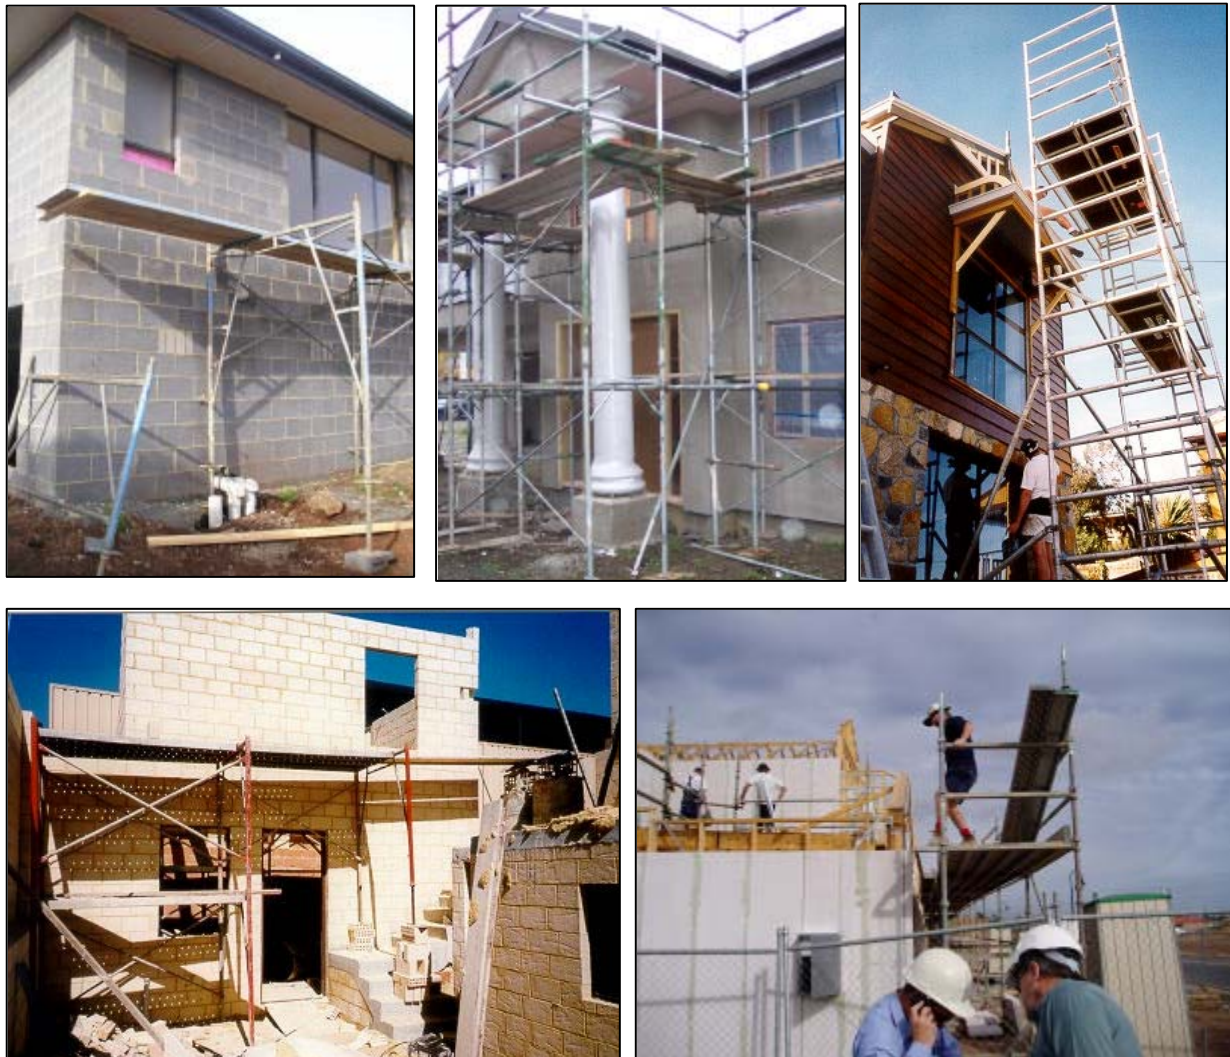
*A selection of scaffolding “shockers” encountered by inspectors during the project. Top, from left, shockers seen in Tasmania, New Zealand and Western Australia. Above left, a shocker in Western Australia and, above right, one in South Australia.*

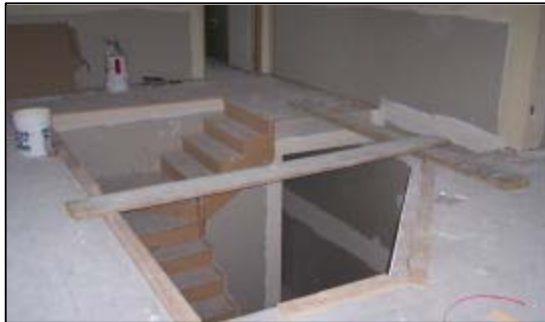
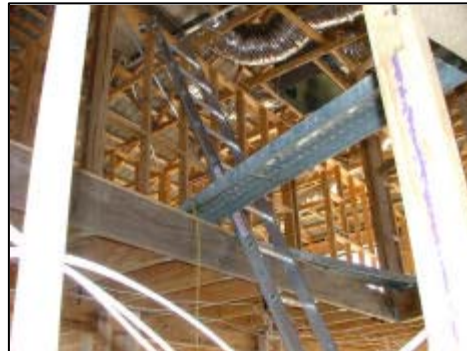
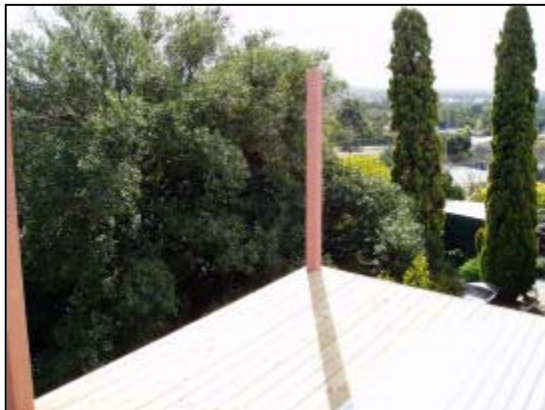
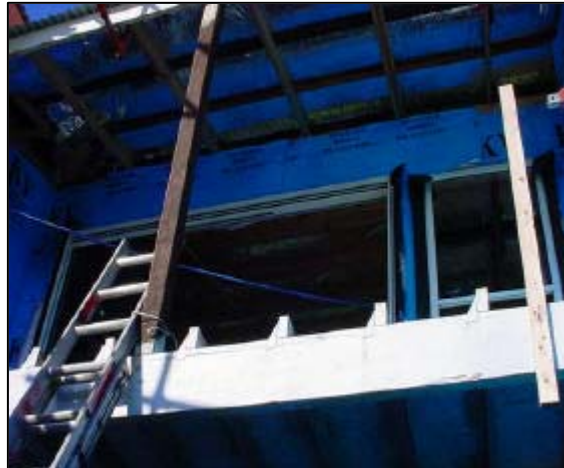
*Workers at risk from lack of stair void protection in New Zealand (top left) and the ACT (top right). Lack of balcony protection in South Australia, (above) and Queensland (right).*

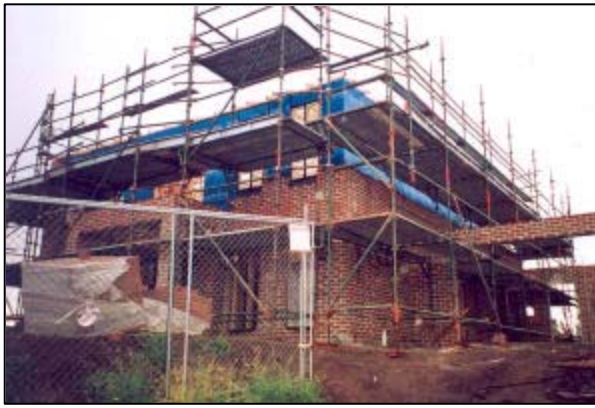
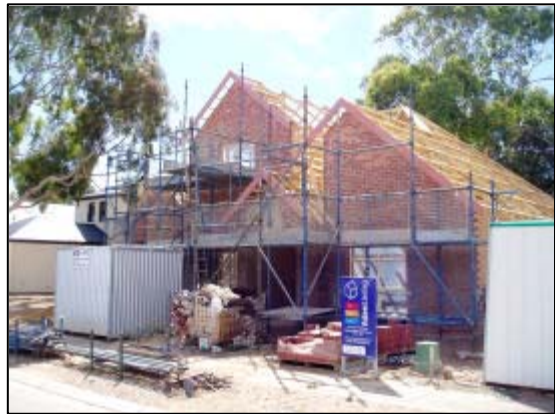
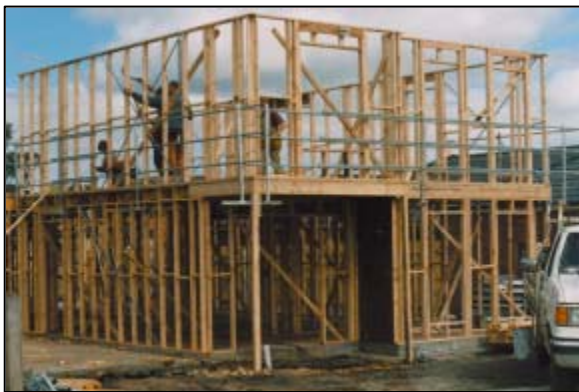
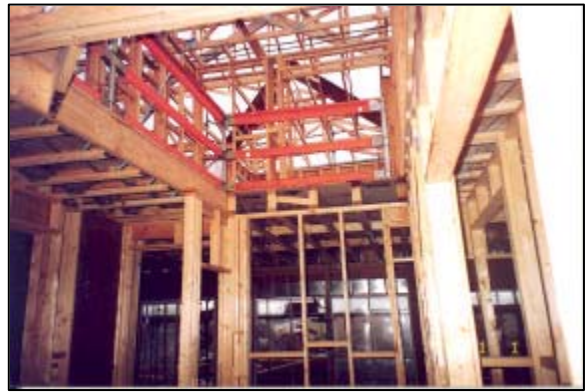
*Compliant perimeter scaffolds on housing sites in Melbourne (above left) and Adelaide (above right).  
Below left: An edge protection system on a housing site in Sydney.  
Below right: Stair void protection on a housing site in Melbourne.*

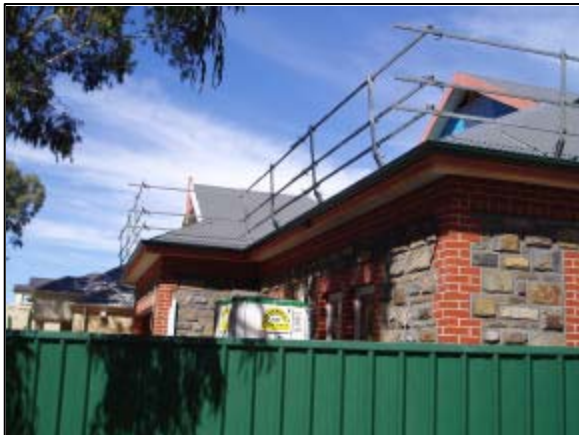
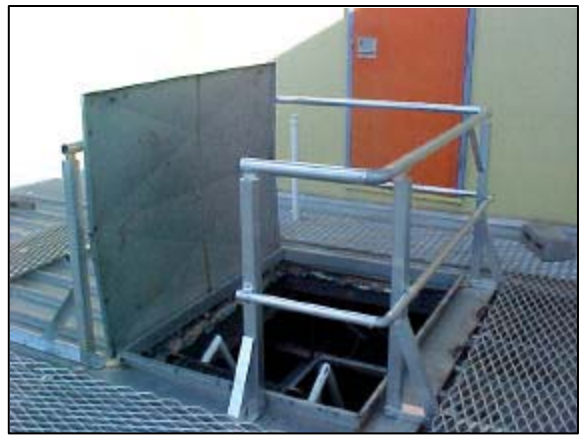
*Above left: Roof edge full-perimeter guardrailing on an Adelaide housing site.  
Above right: Guardrailing on a commercial site in Melbourne for roof access by services installation trades.*
