ELECTRICAL INCIDENT REPORT

**INVESTIGATION OF WILDFIRE
ON 2 DECEMBER 2004
AT LOCATION 745
BATES ROAD
DALYUP WESTERN AUSTRALIA**

25 May 2005

2004-1368

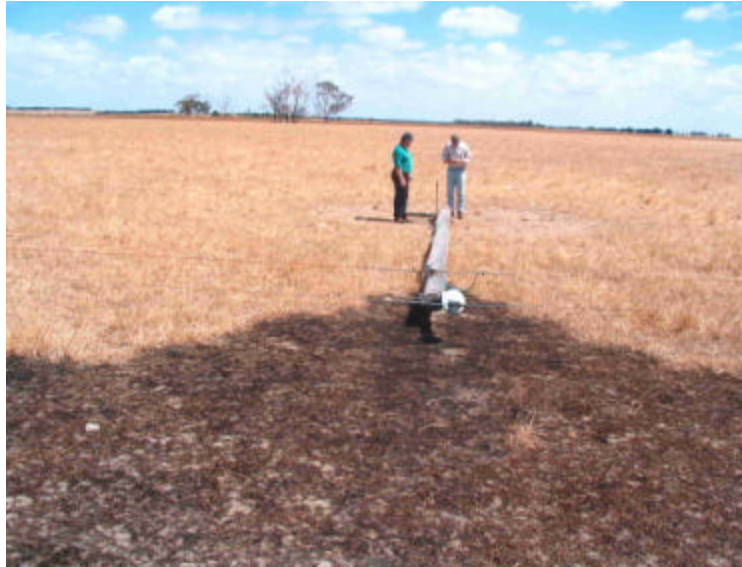
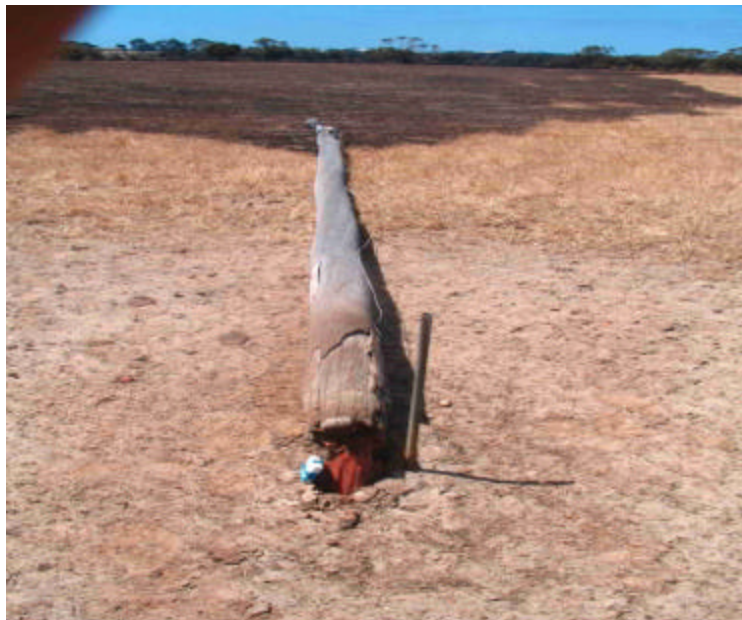
Photographs of Fire Scene Showing Wood Pole D99/12/6

The origin of the fire was in the immediate area where pole D99/12/6 failed and the high voltage 19.1 kV phase conductor contacted the ground.

In summary, it was concluded that the fire was ignited when the 19.1 kV phase conductor came into contact with the ground following the WPC wood pole D99/12/6 falling over in a south easterly direction [Photographs, Appendix A].

- On arrival of the WPC repair crew on the afternoon of Friday 3 December 2004, the WPC pole (D99/12/6) was lying on the ground pointing in a south westerly direction. The phase and earth conductors were both attached to the insulators which were still fixed to pole D99/12/6.

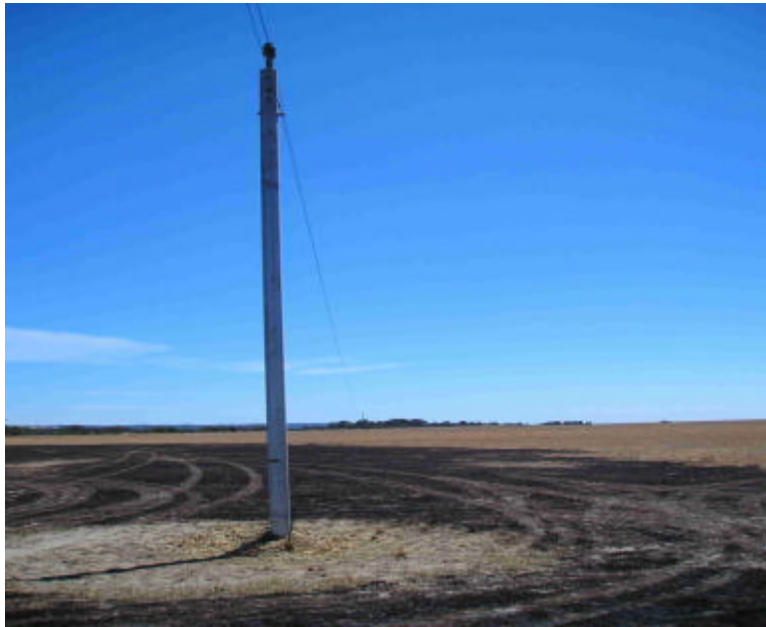
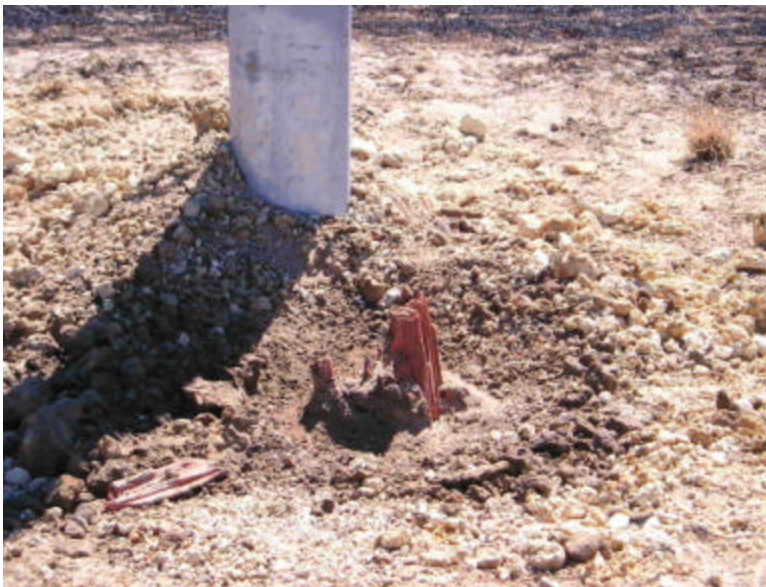
Photographs of Fire Scene Showing the Replacement Steel Pole D99/12/6

- The next pole west of the replaced pole (D99/12/5) appeared to be in a poor condition (where it enters the ground) and on a southerly lean.
- Pole D99/12/6 and surrounding poles were not reinforced (i.e. no RSJ columns/steels fitted).

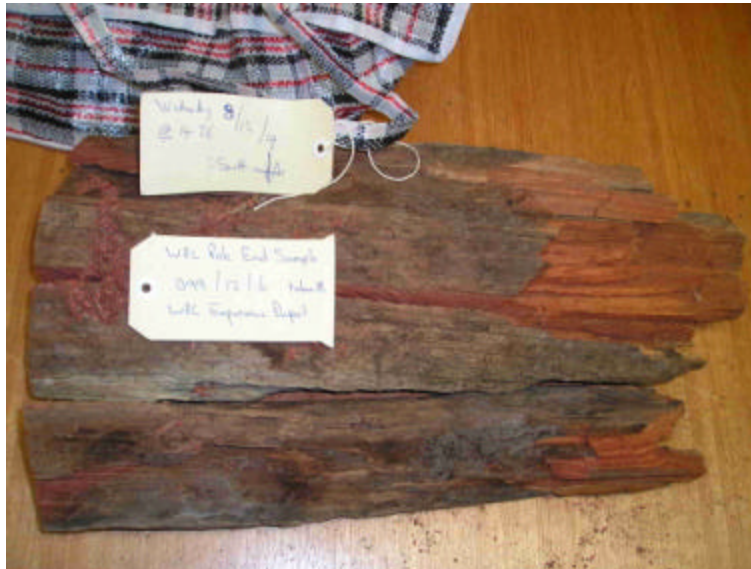
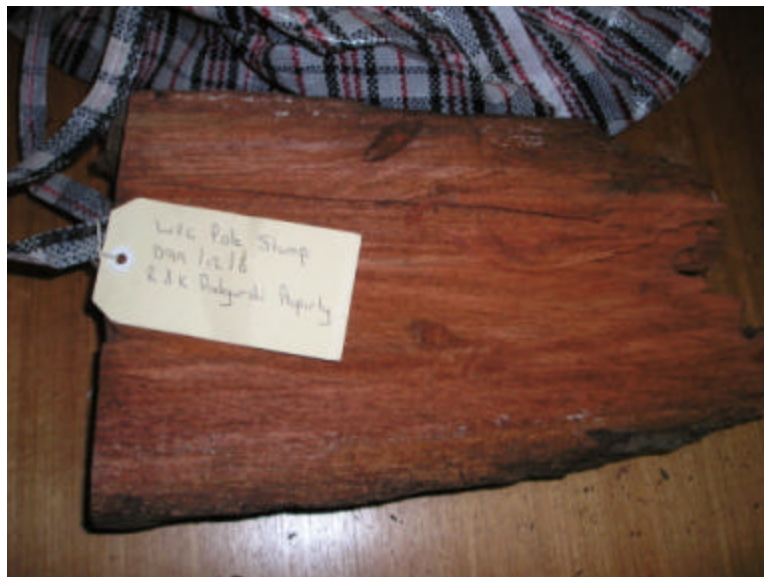
Photographs of WPC Pole (D99/126) Stump End and Pole End Samples

Overall there was a reasonable proportion of splintery fracture, and as expected the sapwood below the ground line was decaying and not contributing to the strength of the cross section.

The wood around the inspection drill holes was sound. There was a small area of rot on one section of the circumference below the ground line that would have little effect on strength.

Although there was internal splitting above the ground line, probing indicated that the wood was sound.

Overall it was considered that the cause of the pole failure was the increasing brittleness of the wood with increasing age and years in service. Jarrah is rated in Australian Standard AS5604-2003 'Timber – Natural durability ratings' as CSIRO Durability Class 2, i.e. the outer heartwood should give 15 to 25 years service in ground.

- Changes its wood pole inspection practices and procedures to ensure that the inspector who conducted the pole inspection can be clearly and positively identified;
- Inspects all the poles in the rural area to the west of Esperance that were erected in 1985 or earlier to determine the remaining structural strength and factor of safety (FOS) of those poles;
- Reinforces or replaces all poles that do not have a residual FOS of 2.0 in respect of the loads specified in ESAA C(b)1; and
- Prepares a plan and program to manage this work.
