## **ELECTRICAL INCIDENT REPORT**

**INVESTIGATION OF WILDFIRE  
ON 2 DECEMBER 2004  
AT LOCATION 1501 DALYUP  
ESPERANCE WESTERN AUSTRALIA**

20 May 2005

2004-1366

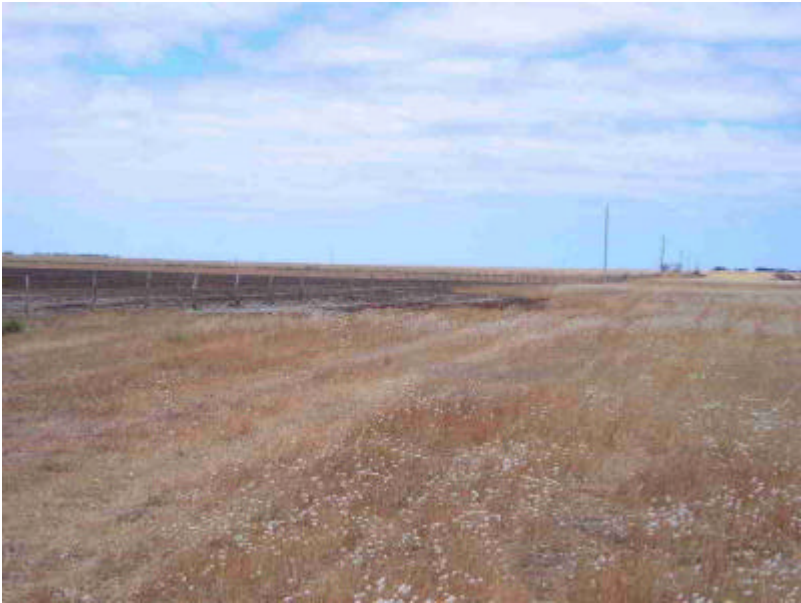
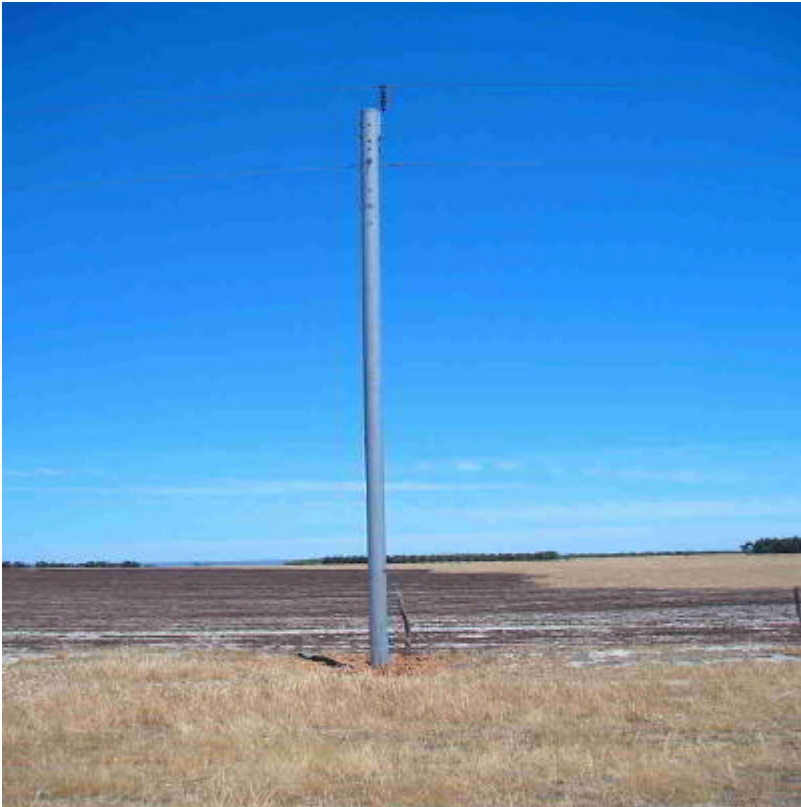
**Photograph of Fire Scene Showing the New Replacement Steel Pole (D250/16/5)**

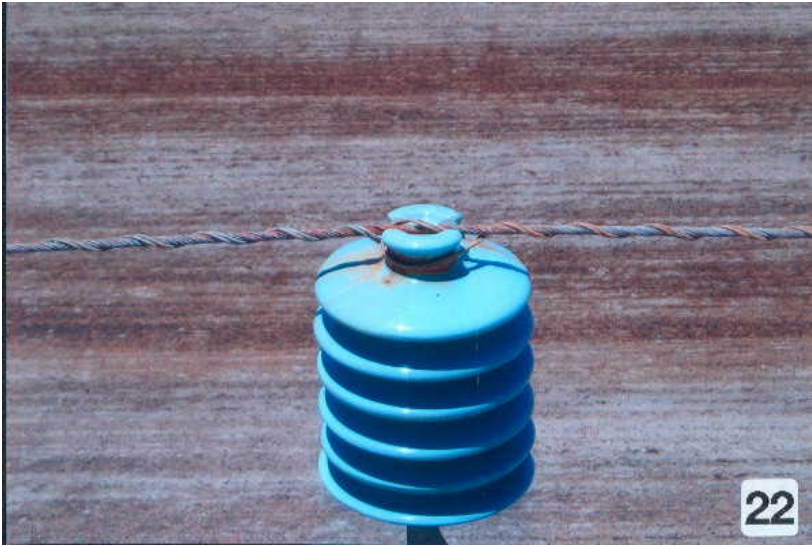
- Visual inspection of the conductor's insulator ties at the two poles either side of the failed pole (D250/16/5) found that the ties were corroded but in a reasonable condition.

**Photograph of Aerial Pole D250/16/6 Insulator and Conductor Tie**

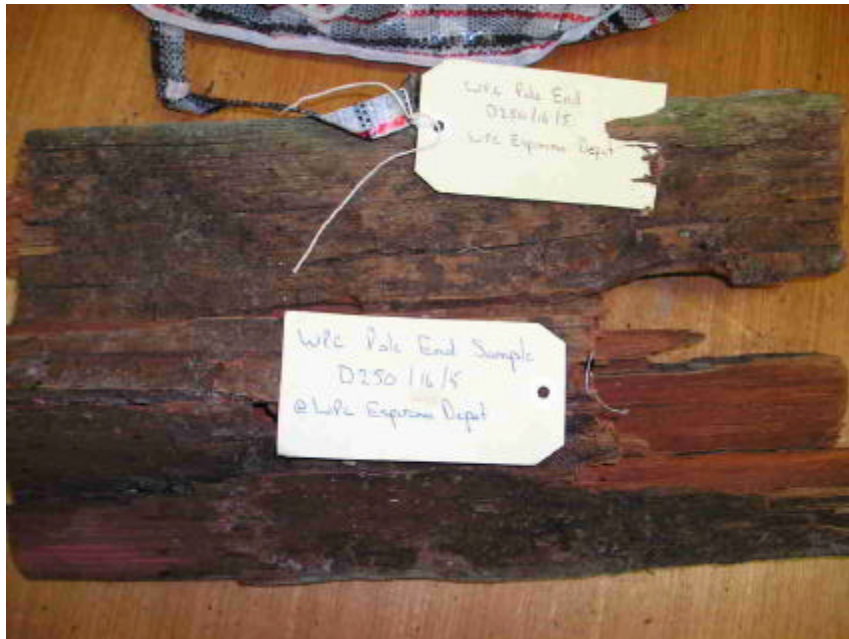
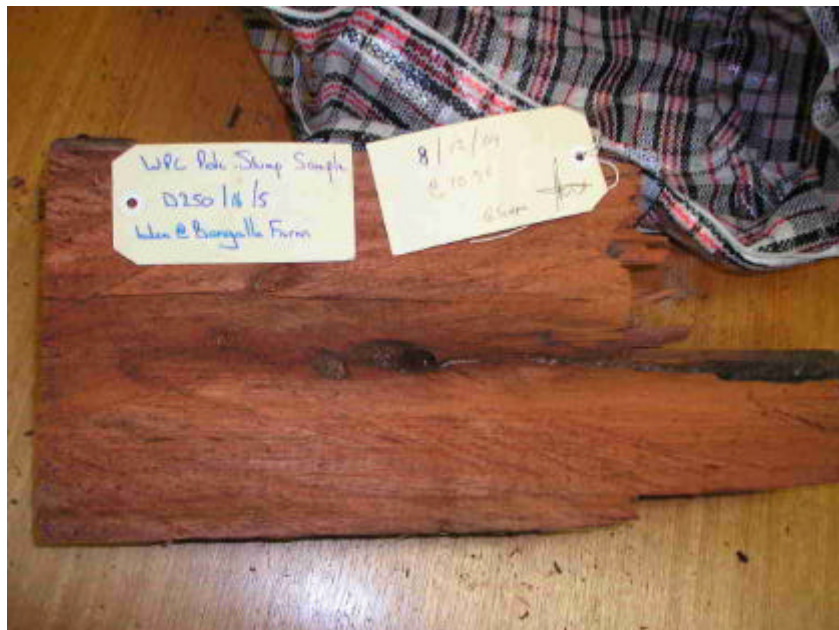
This was a larger pole section, which included some splintering fracture of the outer heartwood but generally brittle fracture. The white plastic plug was removed and probed, which again indicated that the wood was sound although marginally softer than the surrounding. This is attributed to higher moisture content due to contact with the preservative rods.

This section above ground had internal splitting with obviously weathered wood. However, this would have little effect on the strength properties of the pole because there was no associated rot.

Remnants of decaying sapwood were just above the ground line, but standard engineering practice has been to ignore the non-durable sapwood in design unless it has been preservative-treated. The narrow sapwood band of jarrah (typically 12 to 15mm width) means that this species has a very low volume of sapwood in the cross-section compared with many others.

Overall it was considered that the cause of the pole failure was the increasing brittleness of the wood with increasing age and years in service. Jarrah is rated in Australian Standard AS5604-2003 'Timber – Natural durability ratings' as CSIRO Durability Class 2, i.e. the outer heartwood should give 15 to 25 years service in ground.

- Scientific testing of the pole sample stump and pole end by the Forest Products Commission indicated that the samples showed signs of brittleness due to age.

**Photograph of WPC Pole (D250/16/5) Stump End and Pole End Samples**

4. Inspects all the poles in the rural area to the west of Esperance that were erected in 1985 or earlier to determine the remaining structural strength and factor of safety (FOS) of those poles;

5. Reinforces or replaces all poles that do not have a residual FOS of 2.0 in respect of the loads specified in ESAA C(b)1; and
6. Prepares a plan and program to manage this work.
