# gas | focus

## LP Gas Cylinder Location Near Electrical Switchboards

## Energy Safety

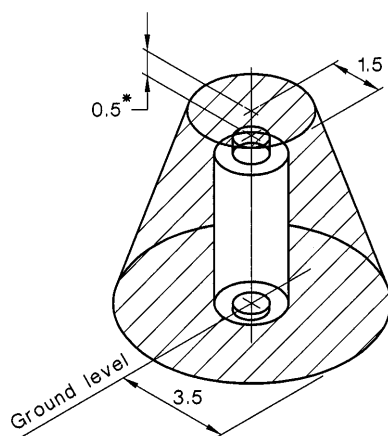
Clause 4.2.2.2 (a) reads, inter alia, that a switchboard shall not be installed within the restricted area surrounding gas cylinders containing flammable gas

products. The restricted zone is depicted in the following diagram:

The hatched area shows the restricted zone around gas cylinders in which a switchboard must not be located

Gas fitters need to ensure that the installation of a cylinder does not result in an electrical switchboard being located within the restricted area.

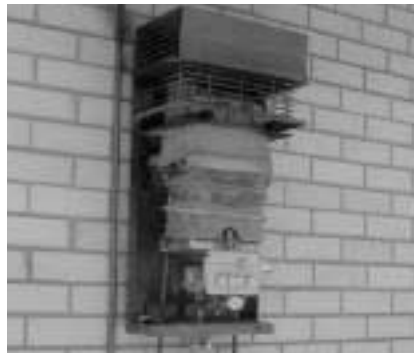
A melt down occurs in an instantaneous water heater when the water flow through the heater is turned off, but the gas continues to flow through to the gas burner without being extinguished.

The water trapped inside the heat exchanger is trapped and turns to steam. As the steam pressure is raised by the burner continuing to heat the heat exchanger, something has to give. Usually it is one of the joins in the heat exchanger that fails, releasing the pressure. If the burner is alight, it is flooded with water from the heat exchanger above and any resultant fire is extinguished.

*Lack on servicing has resulted in a melt down of this water heater's heat exchanger*

Gas appliances being quite simple and generally trouble free, tend to be forgotten until an incident like this occurs. Regular servicing of gas appliances should be carried out, as

required by the manufacturers. Regular servicing may detect such potential incidents.

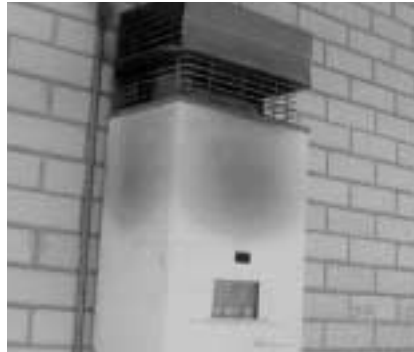
*Radiant heat from the melt down has damaged the water heater's cover*

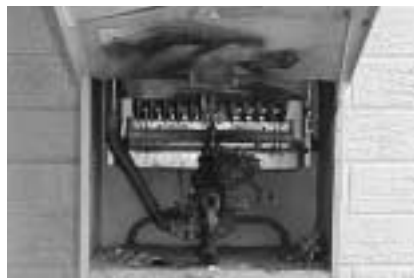
*A different water heater – a melt down has destroyed the appliance*
