Health and Safety Bulletin No. 3

Ruptured aluminium air conditioning flushing canisters

Date: 20 September 2022

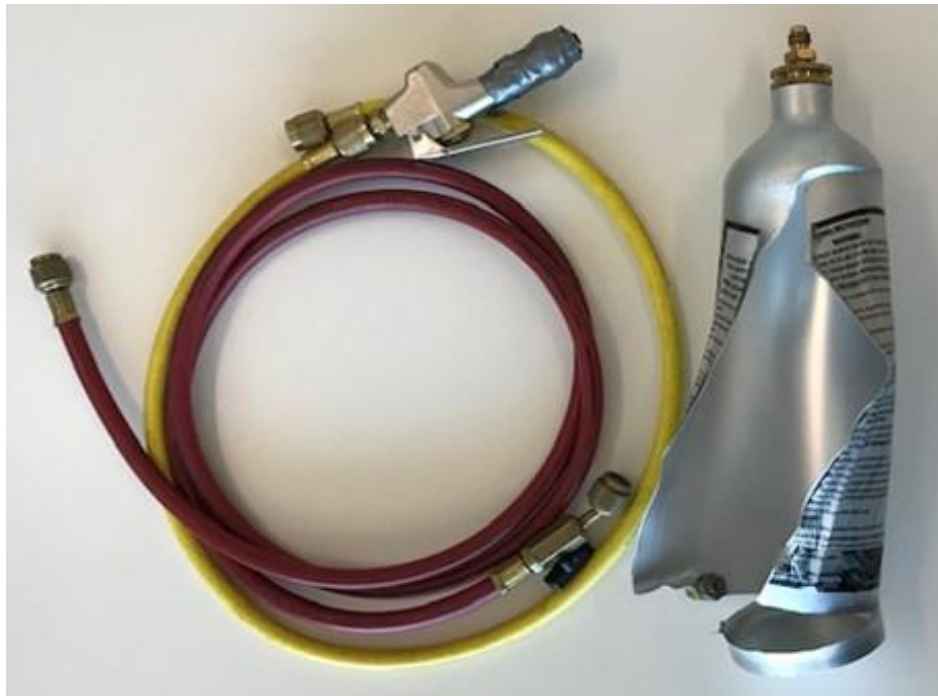
From 2018 to 2021, six serious incidents relating to air conditioning flushing canisters have been reported on mine sites in Western Australia. In five of these incidents, the flushing canister had been over-pressurised and subsequently ruptured.

Flushing canisters are predominantly rated to a maximum pressure of 1,034 kPa (150 psi), and nitrogen supply can be in excess of 16,300 kPa (2,360 psi).

Example of a ruptured flushing canister. Provided by NT WorkSafe.

- Canisters operated outside of their designed pressure rating and/or being damaged.
- No automatic pressure relief system preventing over-pressure of the flushing canister when connected to a nitrogen cylinder.
- Equipment, such as pressure gauges on gas regulators, being misread leading to over-pressurisation.
- Lack of procedures identifying or controlling all foreseeable risks involved in air conditioning flushing.
- Inadequate training in the use of flushing canisters and related equipment.

- the use of flushing canisters with an automatic pressure relief system
- engineering solutions to eliminate the use of flushing canisters
- equipment suitability and condition
- original equipment manufacturer instructions and recommendations
- training and competency of workers.
