Safety and health alert

03/06 Tric Bloc™ concrete median barrier failure

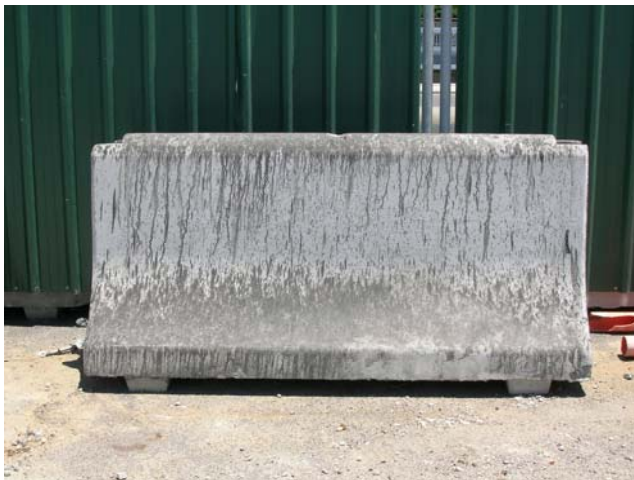
A single 2.5-tonne lifting anchor on a concrete precast Tric Bloc™ Median barrier failed while suspended during transportation around site by a mobile crane, causing the 1.7 tonne concrete element to fall to the ground.

The incident did not result in injury or damage to plant, but the injury/damage potential was high.

- The lifting anchor was designed for a 2.5-tonne load.
- Dynamic loads when performing a pick-and-carry operation can be 3 to 4 times that of lift only operation.

1. Conducting a risk assessment prior to the transportation or movement of precast elements, which should include design considerations.
2. Providing information in relation to the product, detailing the safe use limitations, tare weight and safe transportation. This can be supplied with or affixed to the product.
3. Ensuring precast elements are transported in accordance with the designers/manufacturers' specifications.
4. A competent person checking the precast elements prior to lifting for defects, excessive wear, lifting and transportation risks.
