DETAILED TEST INFORMATION OF FAILED AUTOGAS EQUIPMENT AS CONTAINED IN APPENDIX A OF THE AUTOGAS UPDATE REPORT OF NOVEMBER 08

DOCEP INVESTIGATION: GC/MS analysis of residues recovered from failed LPG regulators (converters) August September 2008

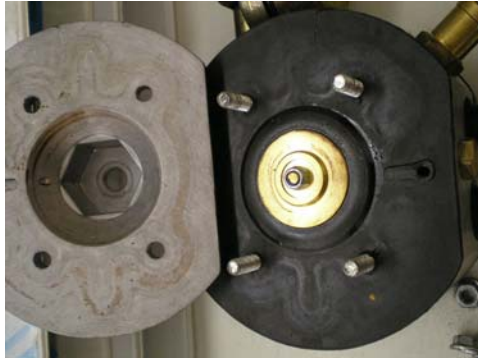
■ 08eh0081.001: Oil from the diaphragm of a failed regulator
(Identified source=ELCO hose on motor vehicle-m/v and some contribution (~9%)
from an Ausquip Bowser hose)

Major Components	Peak ID (time)
Dibutyl Phthalate	20.590 min
Diethyl Adipate	23.044 min
Diethyl Phthalate (9%)	24.948 min
Wareflex and Diethoxyethyl Adipate	30.581 min

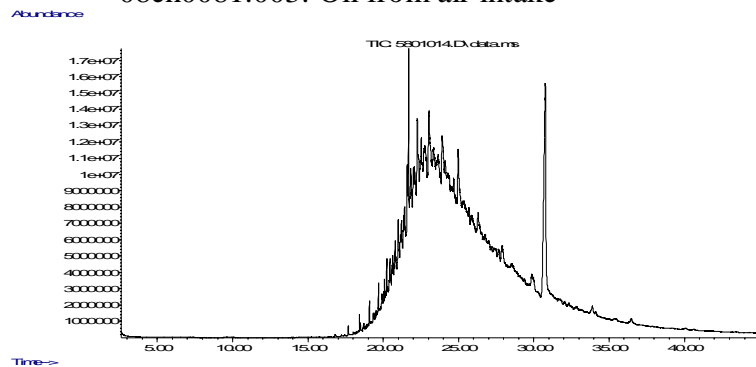
■ 08eh0081.003: Oil from air intake

Mineral oil with Wareflex and Diethoxyethyl Adipate (30.560 min)

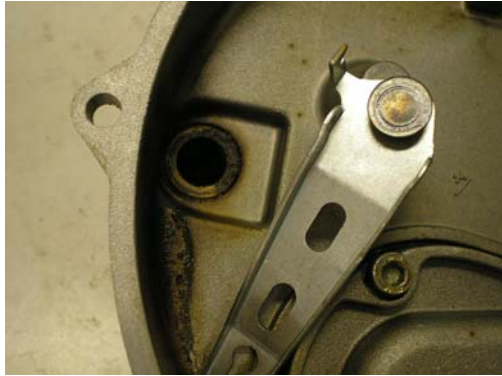
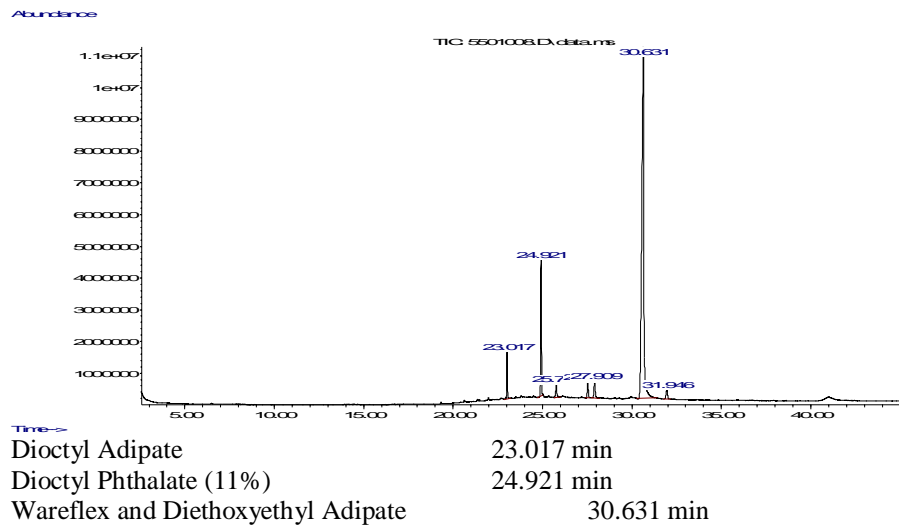
■ 08eh0105.001: oil from inside failed regulator
(Identified source= Ausquip type m/v hose)

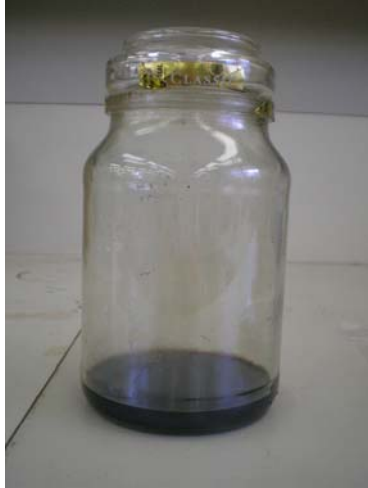
- 08eh0106.001: Brown liquid-MTA (contains thinners solvent @ 18%)

Dibutyl Phthalate	21.2147 min
Diocetyl Adipate	23.736 min
Diocetyl Phthalate (8%)	25.578 min
Wareflex and Diethoxyethyl Adipate	31.250 min

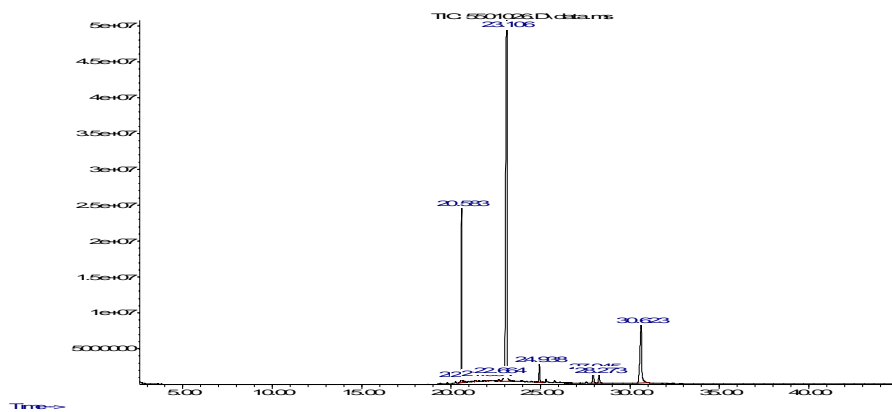
- 08eh0106.001: Residue from brown liquid-MTA (solvent removed)
(Identified source=ELCO type hose from m/v with some contribution (~2%) from an Ausquip Bowser hose)

Dibutyl Phthalate	20.583 min
Diethyl Adipate	23.106 min
Diethyl Phthalate (2%)	24.938min
Wareflex and Diethoxyethyl Adipate	30.623 min

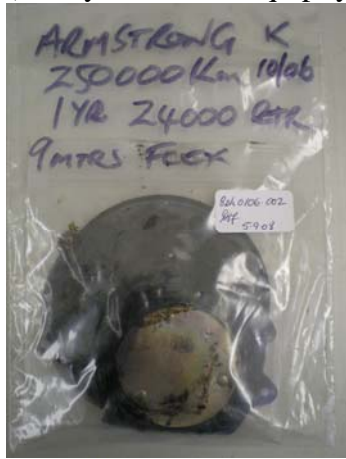
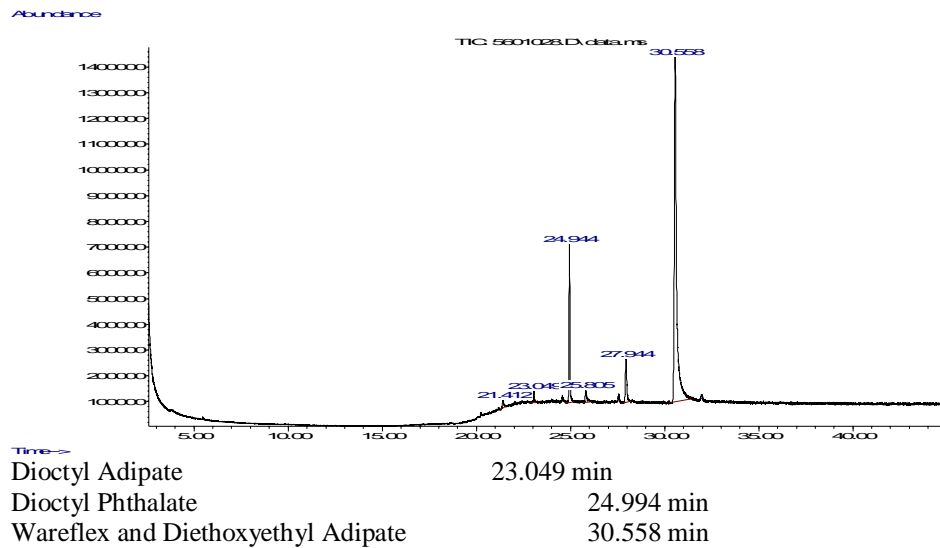
■ 08eh0106.002: Residue from diaphragm, failed regulator (250000Km)-MTA
(Likely source=Ausquip type m/v hose)

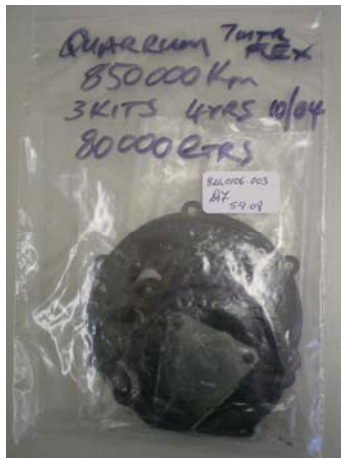
■ 08eh0106.003: Residue from diaphragm, failed regulator (850000Km)-MTA
(Likely source=m/v hose, type unknown)

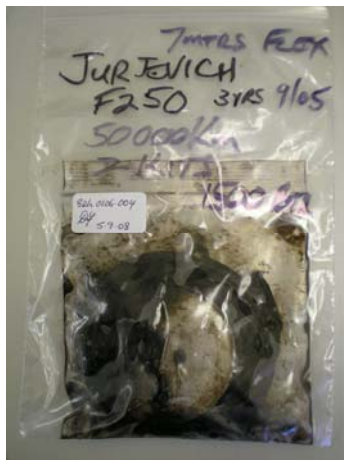
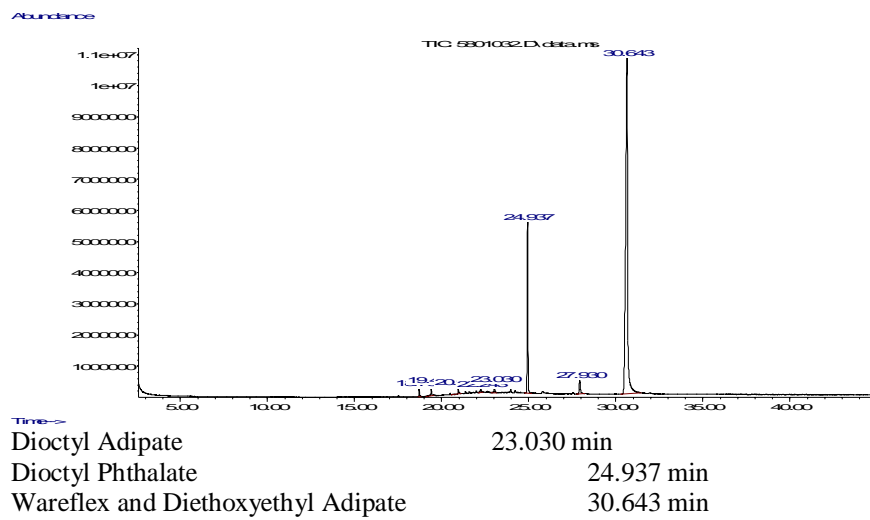
■ 08eh0106.004: Residue from diaphragm, failed regulator (50000Km)-MTA
(Likely source=Ausquip type m/v hose)
