# Safety and health alert

## 01/06 Container side lifter overturns

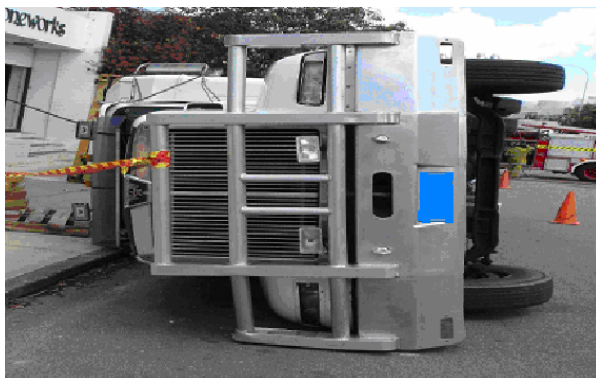
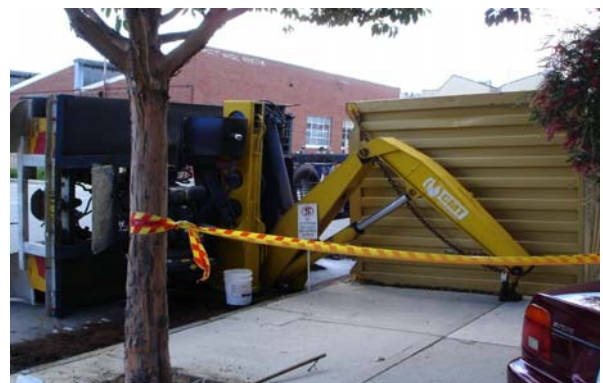
Contrary to the manufacturer's instructions, a commercial driver with a 24-tonne container side lifter failed to fully extend and engage the stabiliser legs when unloading a fully laden sea container. The sea container had a net weight of over 20 tonnes. This resulted in the prime mover, side lifter and the container turning over onto its side and falling onto a pedestrian walkway.

- The operator failed to engage the stabiliser legs prior to operating the container side lifter to unload the container
- The operator failed to operate the container side lifter in accordance with manufacturer's instructions.

1. Operators of container side lifters must be trained in safe working procedures in accordance with the manufacturer's instructions.
2. Employers should assess operators and ensure that they are competent prior to operating this type of plant.
3. Where structural damage has occurred to plant, the employer has a legislative requirement to have damaged plant assessed by a competent person prior to its re-introduction into operation at the workplace, as required by Occupational Safety and Health Regulation 4.38(1) of 1996.
