energy

Bulletin

New Guidelines for the Safe Management of High Voltage Electrical Installations now published

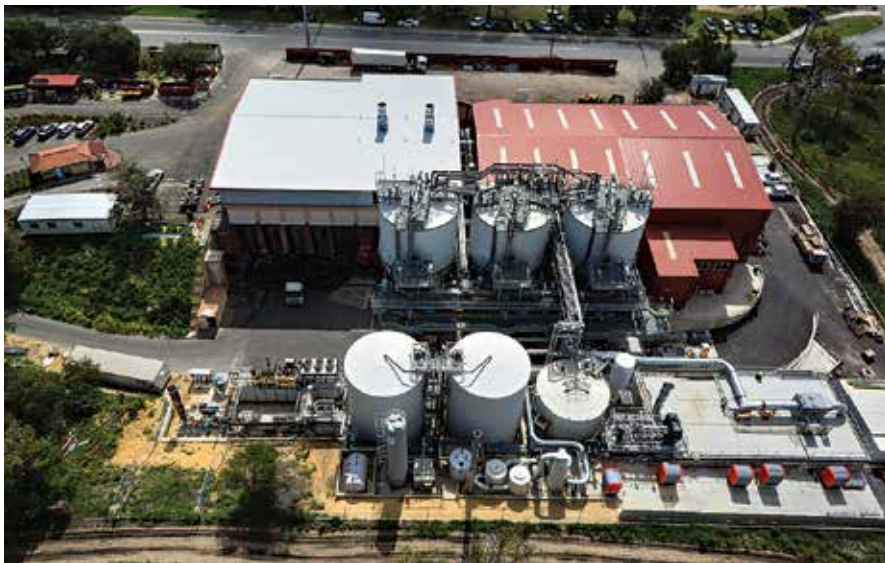
Western Metropolitan Regional Council's Resource Recovery Facility

plant could safely operate until the waste gas became available to fully commission the flare.

Although the use of appliances operating on gas for commissioning while being used for production purposes is prohibited, it was recognised by EnergySafety that at this site the gas flare is a primary safety device and must be available while the plant is in operation.
