## 5. Findings

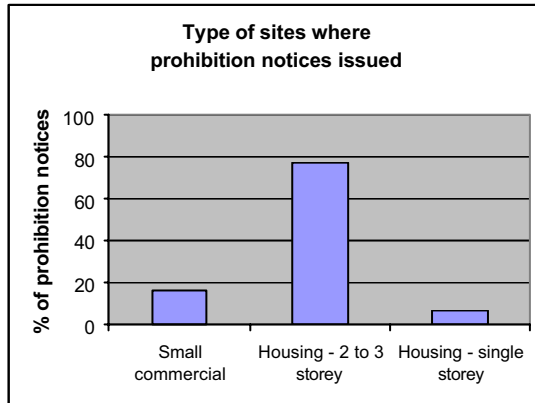
**Graph 1: Prohibition Notices by type of construction**

Graphs 1 and 2, below, provide further detail.

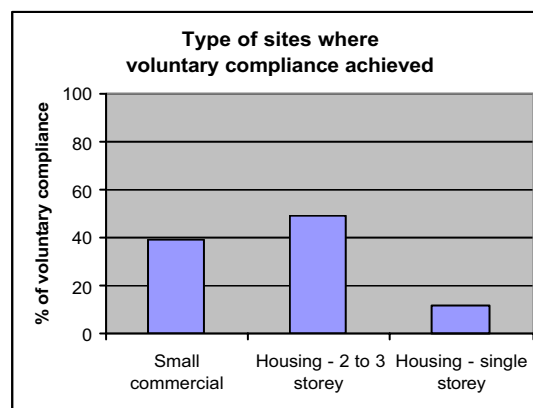
**Graph 3: Voluntary compliance by type of construction**

Housing construction sites accounted for 61% of voluntary compliances recorded.

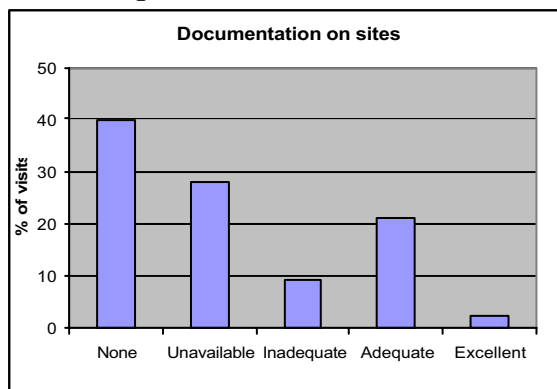
**Graph 4: OHS documentation**

40% of sites visited had no OHS documentation, such as work method statements, safety management plans and/or job safety analyses, setting out how falls were to be prevented when carrying out work at heights.

Where OHS documentation was sighted<sup>1</sup>, inspectors considered it acceptable (excellent or adequate) at only 23% of sites visited.

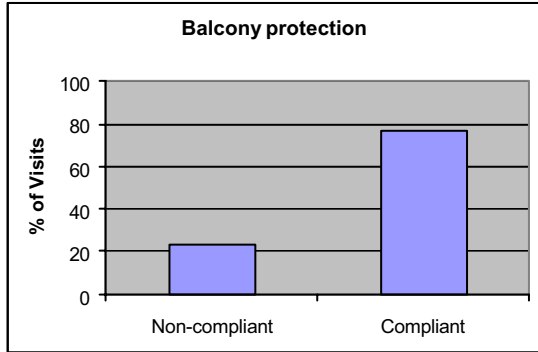
**Graph 5: Balcony protection**

Where controls were needed to prevent workers falling from balconies or down stair voids, they were either non-existent or inadequate on 24% of such sites.

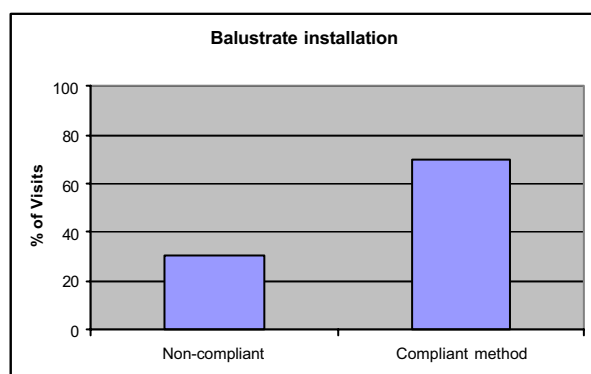
**Graph 7: Balustrade installation method**

Work systems for both tasks were found to be non-compliant at 30% of such sites.

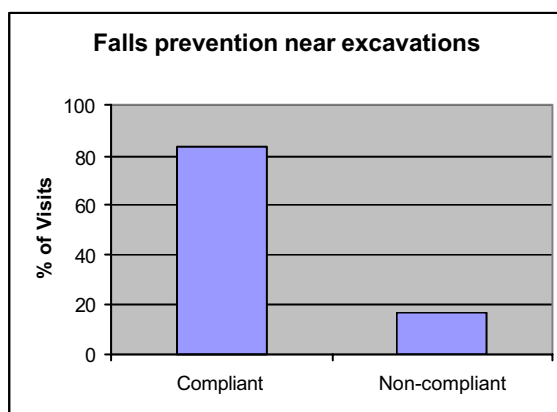
**Graph 9: Falls prevention near excavations**

On sites with excavations, required fall protection around excavations was either absent or inadequate at 17% of such sites, as illustrated in Graph 9, below.
