Safety and health alert

17/09 Employee injured while inflating tyre-no warning signs

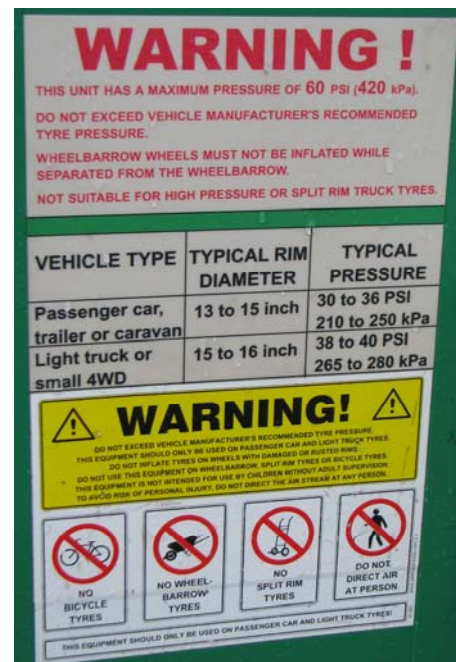
Divided wheels or split rims are those wheels in which the rim is in two halves, which are bolted together. They are most often fitted to wheelbarrows and trolleys used in service stations and retail shops and only hand pump/foot pumps should be used to inflate such pieces of plant.

At the service station where the accident happened there were no warning signs posted next to or near the air hose or tyre inflation point. Therefore the users were unaware of the dangers of using an air hose on bicycles, wheelbarrows, hand trolleys, footballs, basketballs and other sporting equipment.

1. Only use a foot or hand pump to fill the following tyre types:
 - Bicycle,
 - Wheelbarrows,
 - Hand trolleys,
 - Footballs, basketballs and other sporting equipment.
2. Warning signs should be in place.
