Safety and health alert

07/05 Gardener fatally injured in roll-over

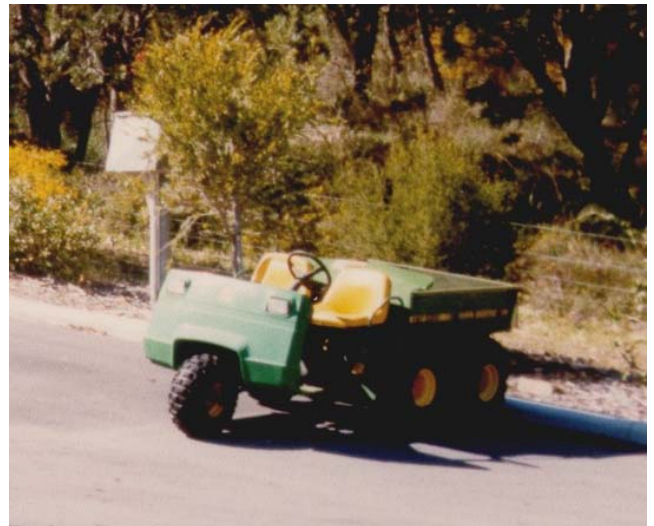
AMT 622 - All Material Transporter

A self-employed landscape gardener was driving a utility vehicle down a steep bitumen roadway. He made a right hand turn into a driveway and the utility rolled over, pinning him underneath and causing fatal injuries. The utility he was driving was a 1979 John Deere two-seater five- wheel AMT 622 - All Material Transporter. These utilities do not come fitted with ROPS or seat belts. The gardener was working on a large private property at the time, and the roadway and driveway formed part of the property.

- Steep bitumen slopes are very hazardous when using these utilities.
- Five-wheel configurations with one front wheel located in the centre provide less stability than six wheel configurations, especially while turning.
- Speed is a major contributing factor in rollovers.

1. Reduce speed and exercise extreme caution on steep slopes. Always use brakes when going down slopes.
2. Drive very slowly when turning.
3. Ensure regular maintenance and immediate repair of faults or damage. Pay particular attention to tyres, brakes and steering.
4. Read and become familiar with the operators manual regarding safe use information.
5. Never allow children to operate utilities. These vehicles are not intended for recreational use.
6. Be aware and adhere to all safety decals on the utility and ensure that they are clearly legible.
7. Reduce load size in cargo box when operating on hilly or rough ground.
