Safety and health alert

09/05 Lack of maintenance on road train leads to joint Police/WorkSafe action

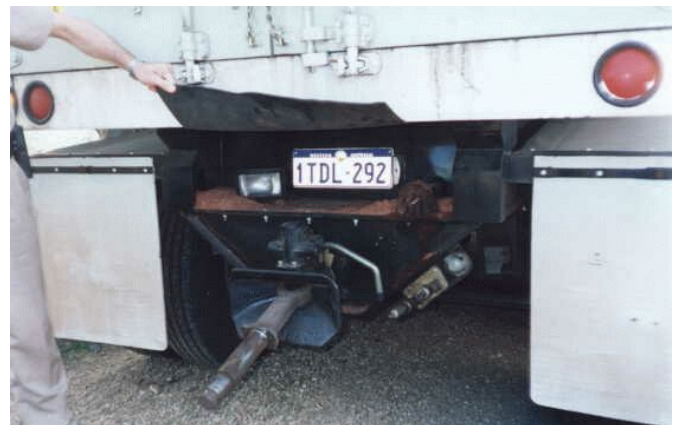
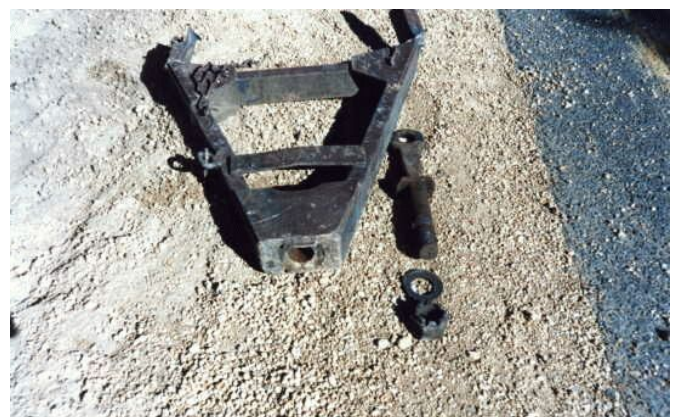
WA Police Service attended a serious motor vehicle collision in South-West WA. A split pin and a castellated nut failed, causing a road train trailer to detach and crash into an oncoming vehicle. The police investigation concluded the primary cause was a lack of maintenance of a part of the road train vehicle. The WA Police Service requested DOCEP, WorkSafe Division investigate the maintenance aspects of the road train, including the obligations and responsibilities vehicle owners have under the *Occupational Safety and Health Act 1984* in relation to maintaining the vehicle in a safe roadworthy condition.

- Commercial vehicles are workplaces to which the occupational safety and health laws apply.
- The manufacturer's maintenance instructions in respect of the ringfeder towing eye were not followed.
- No maintenance records existed for the trailer.

1. Ensure plant and vehicles are operated and maintained in accordance with the manufacturer's instructions and specifications.
2. Ensure regular inspections to identify hazards, assess risks and control risks.
